TMPR3927 Specification Update

Revision History

TMPR3927F, TMPR3927AF, TMPR3927BF, TMPR3927CF

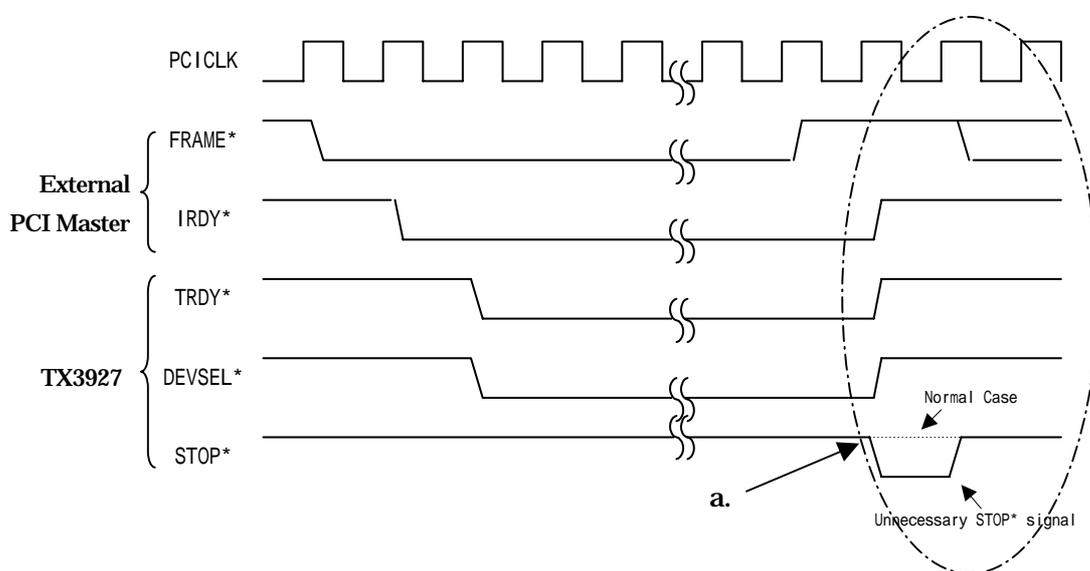
Figure 1 Unnecessary STOP* signal assertion operation

As illustrated in Figure 1 below, the PCI controller in the TX3927 may, under particular conditions, assert unnecessary STOP* signals when the external PCI master is performing burst access to the TX3927 local memory, exactly when the burst cycle ends (a. in Figure 1).

This phenomenon occurs under the following conditions:

- (1) When the burst cycle is in the Read state
 - If OFIFO becomes empty just before timing a. (in the above figure) when the target control register (TC : address 0xFFFE_D090) in the PCI controller has set OFIFO8 Clock Rule Enable (OF8E : bit 3) to "Disable."
- (2) When the burst cycle is in the Write state
 - (a) If IFIFO becomes full just before timing a. (in the above figure) when the target control register (TC) in the PCI controller has set IFIFO8 Clock Rule Enable (IF8E : bit 4) to

- (b) If the CPU core requests the bus at timing a. (in the above figure) while an other bus master of an internal bus is executing a bus cycle and PSNP (PCI snoop : bit 11) of the chip configuration register (CCFG) has been set to “Disable.”

- (1) When the burst cycle is in the Read state
Set OF8E of the target control register (TC) in the PCI controller to “Enable.”
- (2) When the burst cycle is in the Write state
Set IF8E of the target control register (TC) in the PCI controller to “Enable,” and also set PSNP of the chip configuration register (CCFG) to “Enable.” In this situation however, it is prohibited to use the Data cache in the Write-back mode.

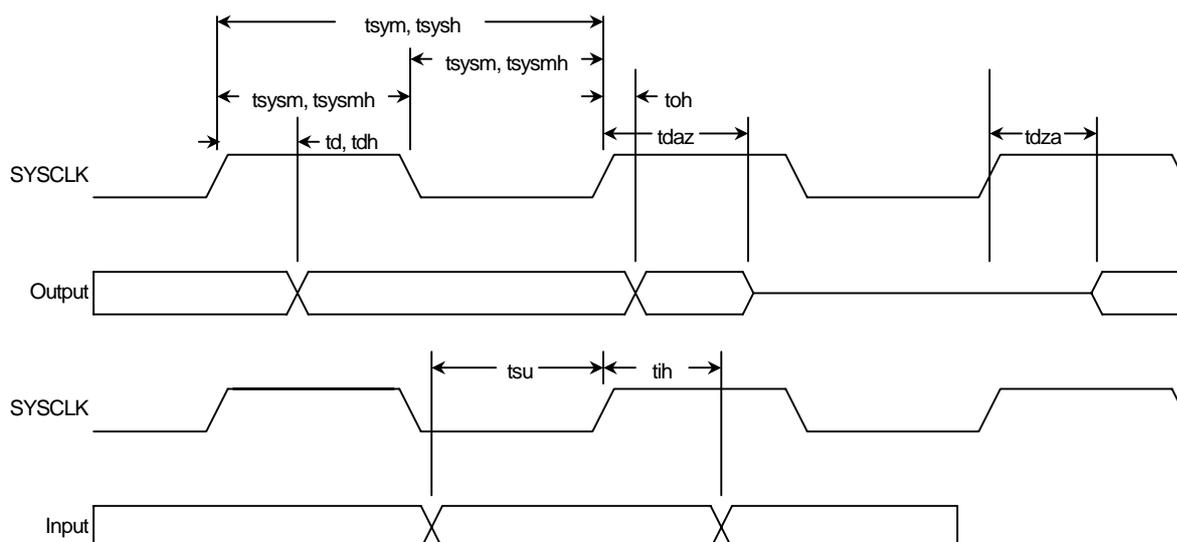
【Timing Diagram (SDRAMC, ROMC signals)】

- (1) ACK*, DATA[31 : 0], CE[7:0]*, OE*, ACE*, SWE*, BWE[3 : 0]*, ADDR[19 : 2], DMAACK[3 : 0], DMADONE*, PIO[15 : 0], TIMER[1 : 0]
- (2) ACK*, DATA[31 : 0], NMI*, INT[5 : 0], DMAREQ[3 : 0], DMADONE*, PIO[15 : 0]
- (3) ACK*, DATA[31 : 0], BWE[3:0]*, SWE*, DMAACK[3 : 0], DMADONE*, PIO[15 : 0], TIMER[1 : 0]
- (4) CE[7:0]*, BE*[3:0], OE*, ACE*, ADDR[19 : 2]

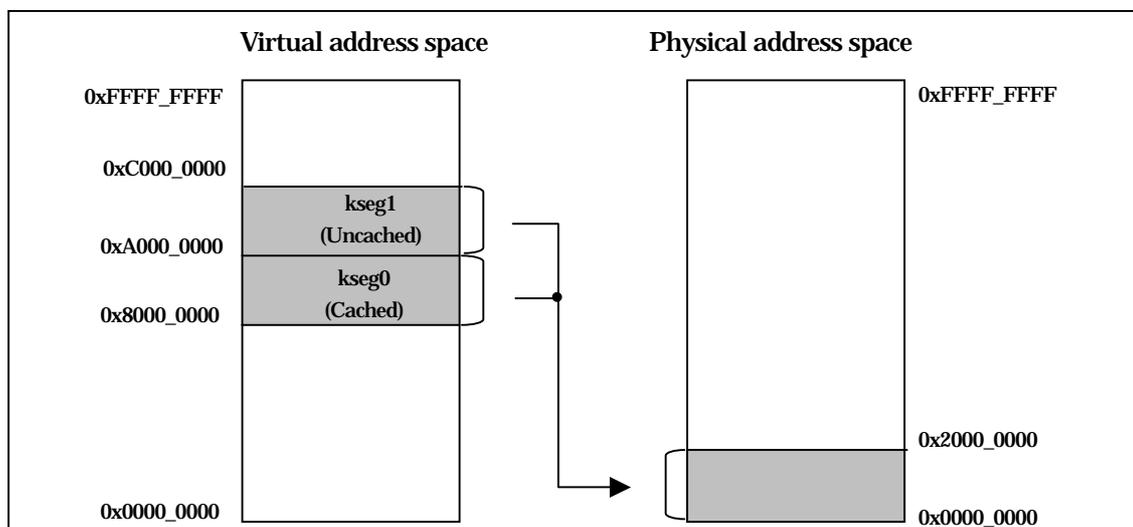
CACHE instruction which cause flash of data cash is one whose operation field (bit20:16) is 0x01, 0x15 or 0x19.

In the burst write operation that is caused by cache replacement from cache miss, this malfunction doesn't occur.

So reading data from cached area and writing the data to uncached area whose physical address is the same as

reading address is equal to flash of data cache by CACHE instruction.

For example, if data address that is target of cache flash is 0x8000_0000, please operate following 1) - 3).

1) Read out data from 0x8000_0000.

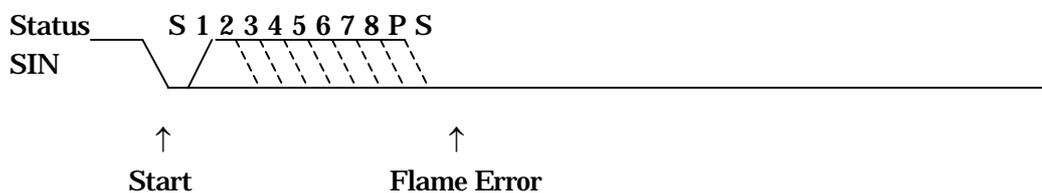
(abnormal movement)

- The receive status stops as Idle, because the start bit after flaming error can't be recognized.

This malfunction may occur, depending on your error handling. If the conditions of this malfunction apply to your system, the TX3927 can't detect the break signal. So please handle the break signal with the flame error.

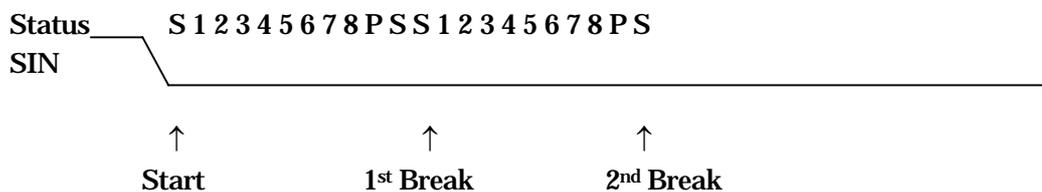
(normal movement)

The TX3927 can detect break signal normally, when break signal is synchronized with start bit (The received data is low continuously right after the start bit recognition.).

- The break signal can be detected normally, when the received data is low continuously right after the start bit recognition.

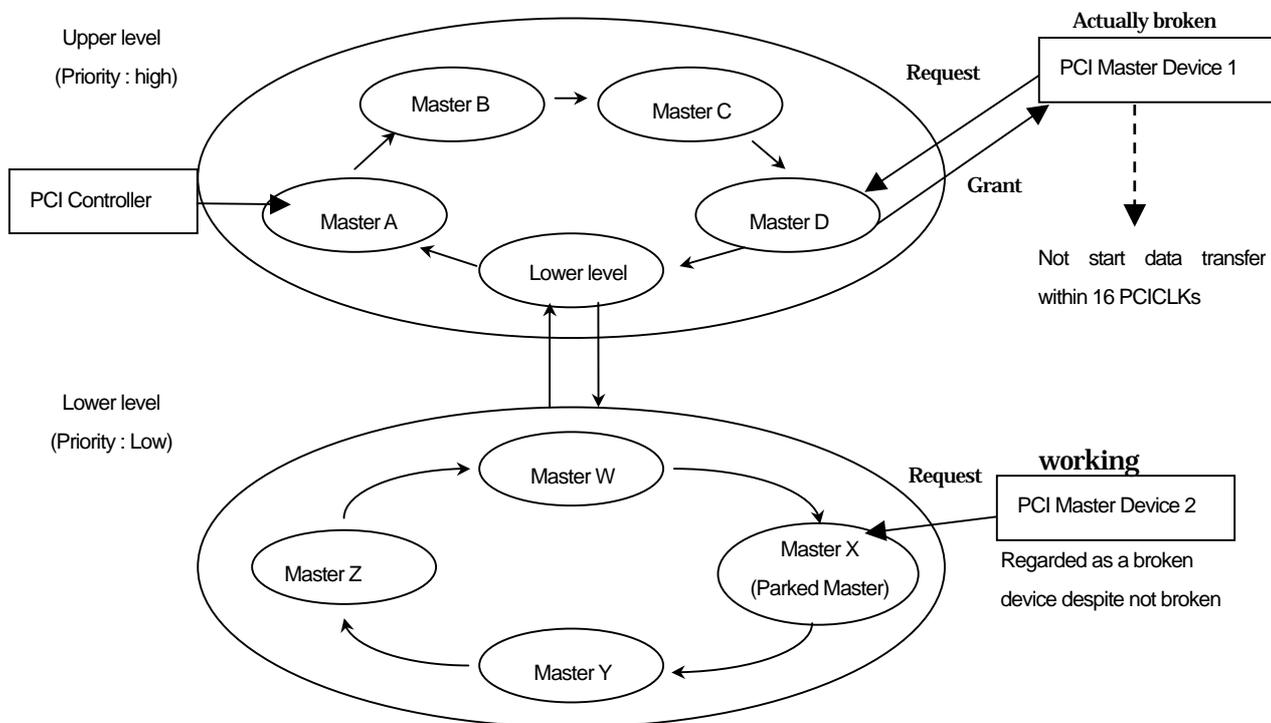
State of PCI bus arbiter (an example when the problem occurred)

If you enable "PCI broken master check function", a working master device may be regarded as a broken master device and detached from PCI bus arbiter.

(3) When a master device assigned to the upper level arbiter is detected as a broken device, another master device assigned to the lower level arbiter activates a PCI bus request and has the highest priority among other devices assigned to the lower arbiter. In the lower arbiter, master W right after reset or a master which got PCI bus at last has the highest priority. (A master with highest priority is called a parked master.)

If all the conditions above are taken simultaneously, the problem will come up and the parked master device will be detached from the PCI bus arbiter.

- (1) Do not use "Broken Master Check Function" by not setting BMCEN bit of PBAPMC register to 1.
- (2) If you must use "Broken Master Check Function" then only use the upper level arbiter. (Master A, B, C, and D)
